# FLOWER GARDEN BANKS NMS IMPACTED BY HURRICANE IKE

A "quick look" assessment cruise on board the M/V EAGLE RAY was conducted on October 10th by FGBNMS staff and volunteers to determine the impacts of Hurricane Ike at the East and West Flower Garden Banks.

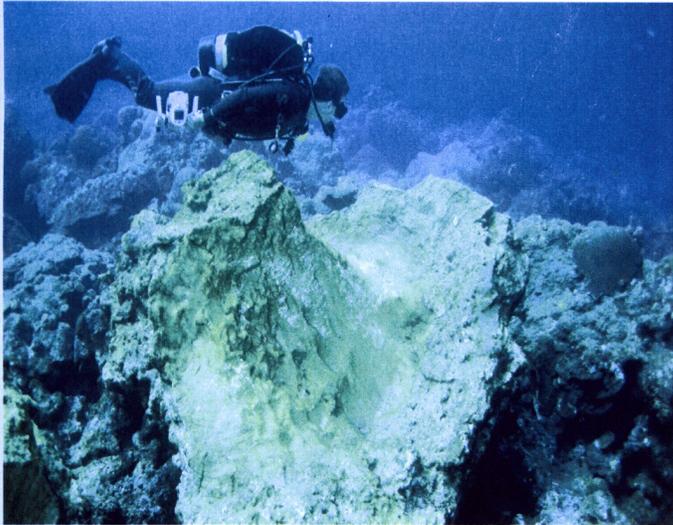
Fig. 1. Eric McHugh hovers over a large overturned boulder coral close to EFGB#2 mooring.

Surveys were conducted at EFGB buoy #'s 2 and 5, and at WFGB buoy #2. Multiple large boulder colonies had been dislodged and moved across the reef, leaving large craters and paths of impact along the track of displacement. Barrel sponges (*Xestospongia muta*) were sheared off, either completely, or partially, although some were observed with no injuries. Scouring of approximately 3' of sand from the sand flats and around bases of coral outcroppings was evidenced. The *Madracis* fields on the eastern flank of the EFGB had experienced significant breakage. Blowout holes around boulder colonies in the *Madracis* field were numerous.

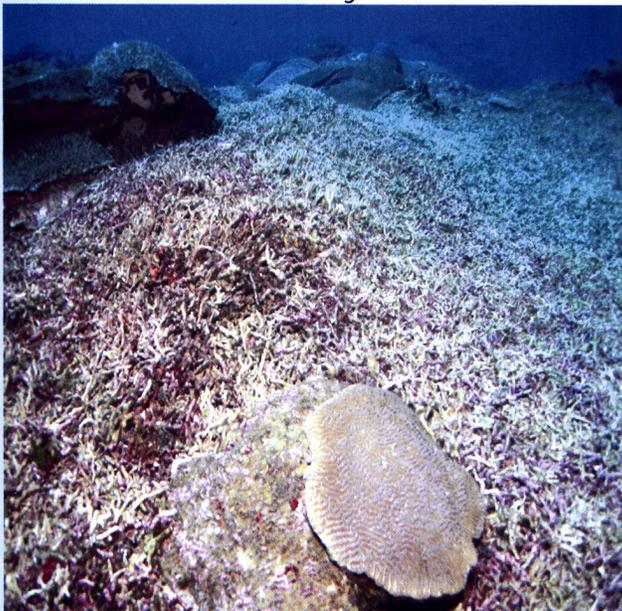
Fig. 2. Field of yellow pencil coral (*Madracis mirabilis*) are seen broken in place due apparently to downward forces produced by the storm.

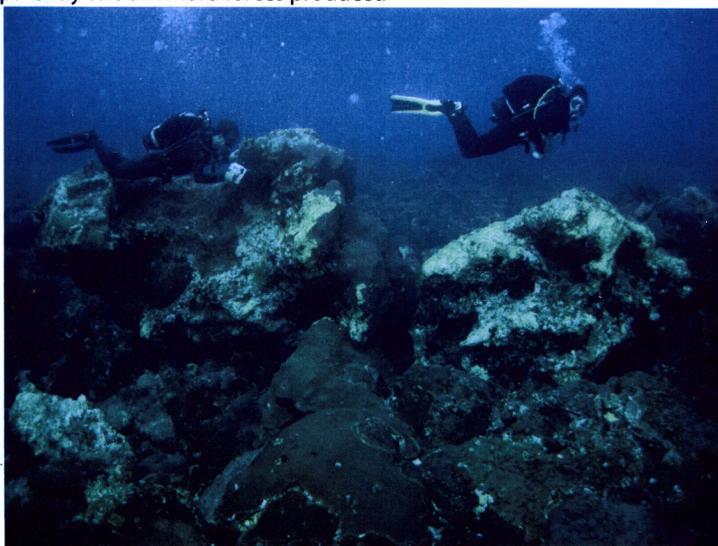
Fig. 3. Eric McHugh and Marissa Nuttall hover over large boulders of dislodged corals close to the WFGB#2 mooring.
