TITLE: Remediation for the Pacific Crossing-1 North and East Submarine Fiber Optic Cables in the Olympic Coast National Marine Sanctuary.

LOCATION: Olympic Coast National Marine Sanctuary, off the coast of Washington

SUMMARY: This Environmental Assessment evaluates alternatives for addressing the existing burial condition of a trans-Pacific fiber optic cable traversing the Olympic Coast National Marine Sanctuary. The cable was laid in 1999-2000. Segments of the cable are not sufficiently buried, and the proposed action is to address this condition ("cable remediation").

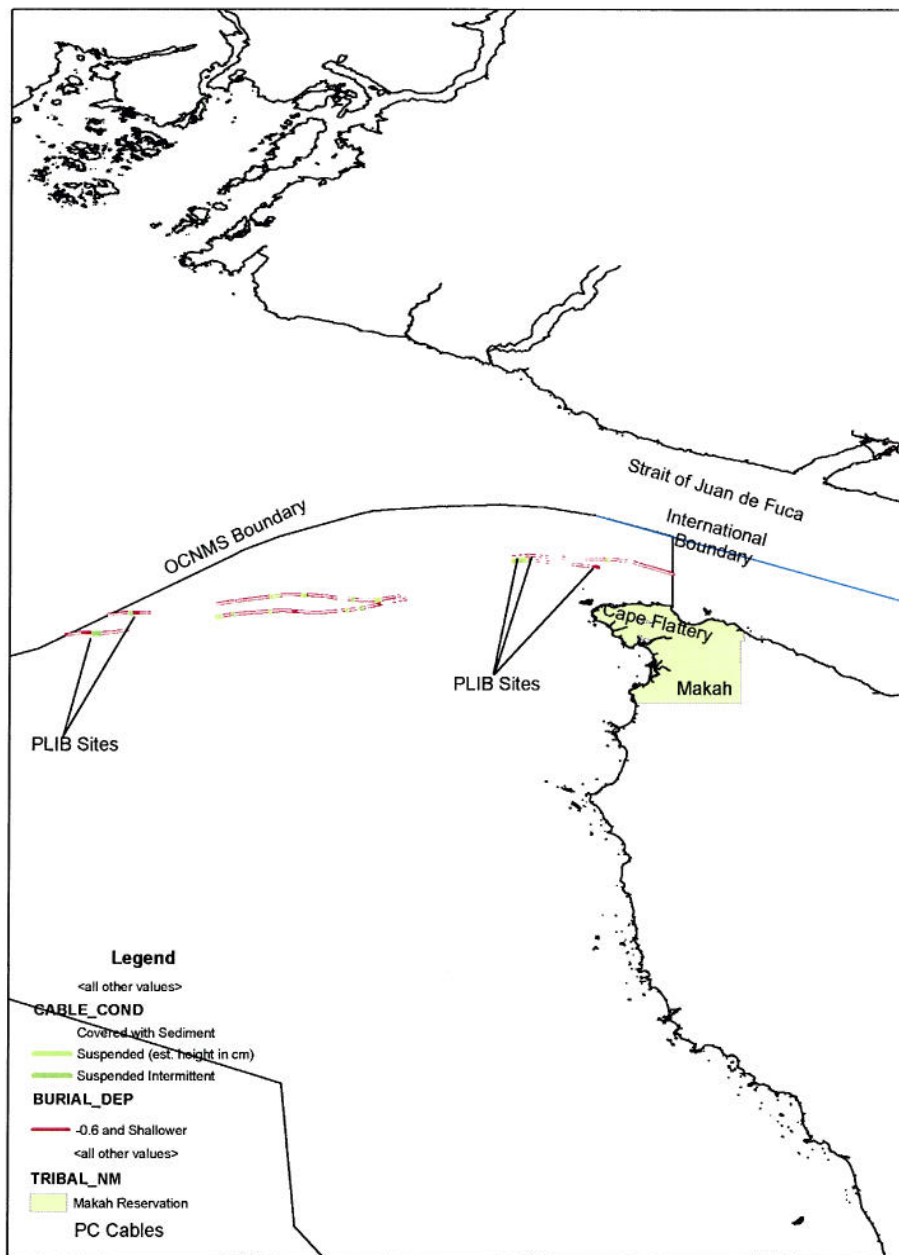
Figure 1 Pacific Crossing-1 Cables in the Olympic Coast National Marine Sanctuary

These values include a minimum cumulative distance of 2.3 km (1.48 miles) that is visible on or above the sediment surface in OCNMS and poses a hazard to fishers (Table 1). Shallowly buried, unburied, and suspended cable sections are widely distributed along both PC-1 cable routes in OCNMS (Figure 1).

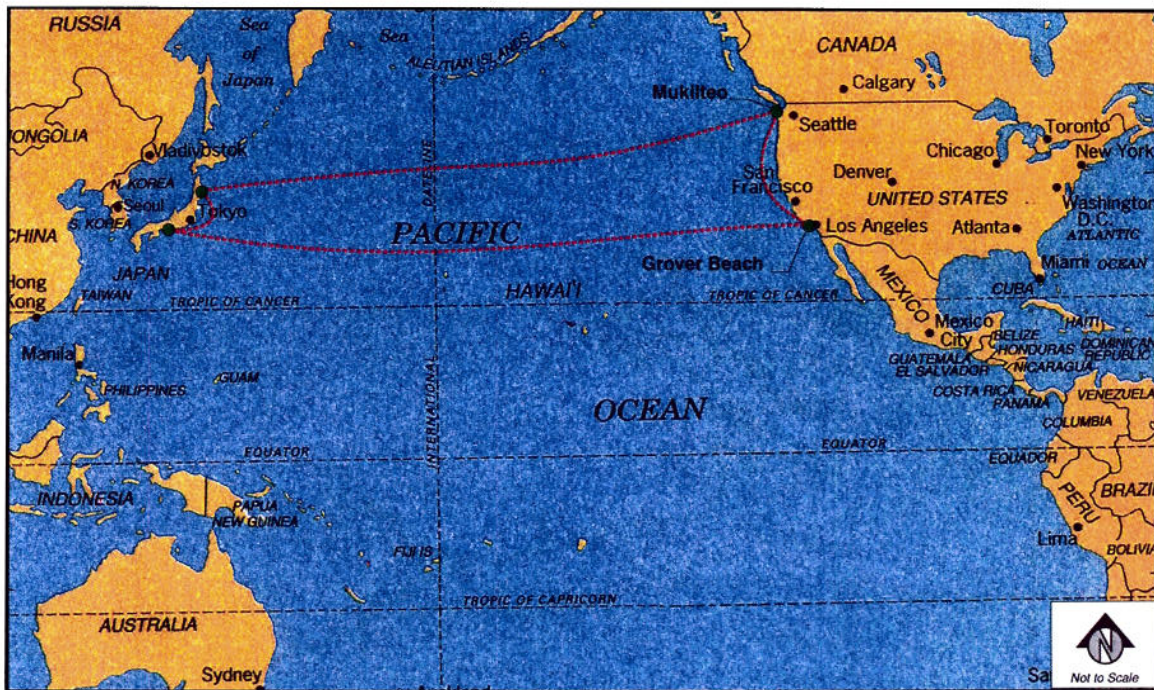
Figure 2 The PC-1 Submarine Fiber Optic Cable System Project Route (from David Evans and Associates 1998)

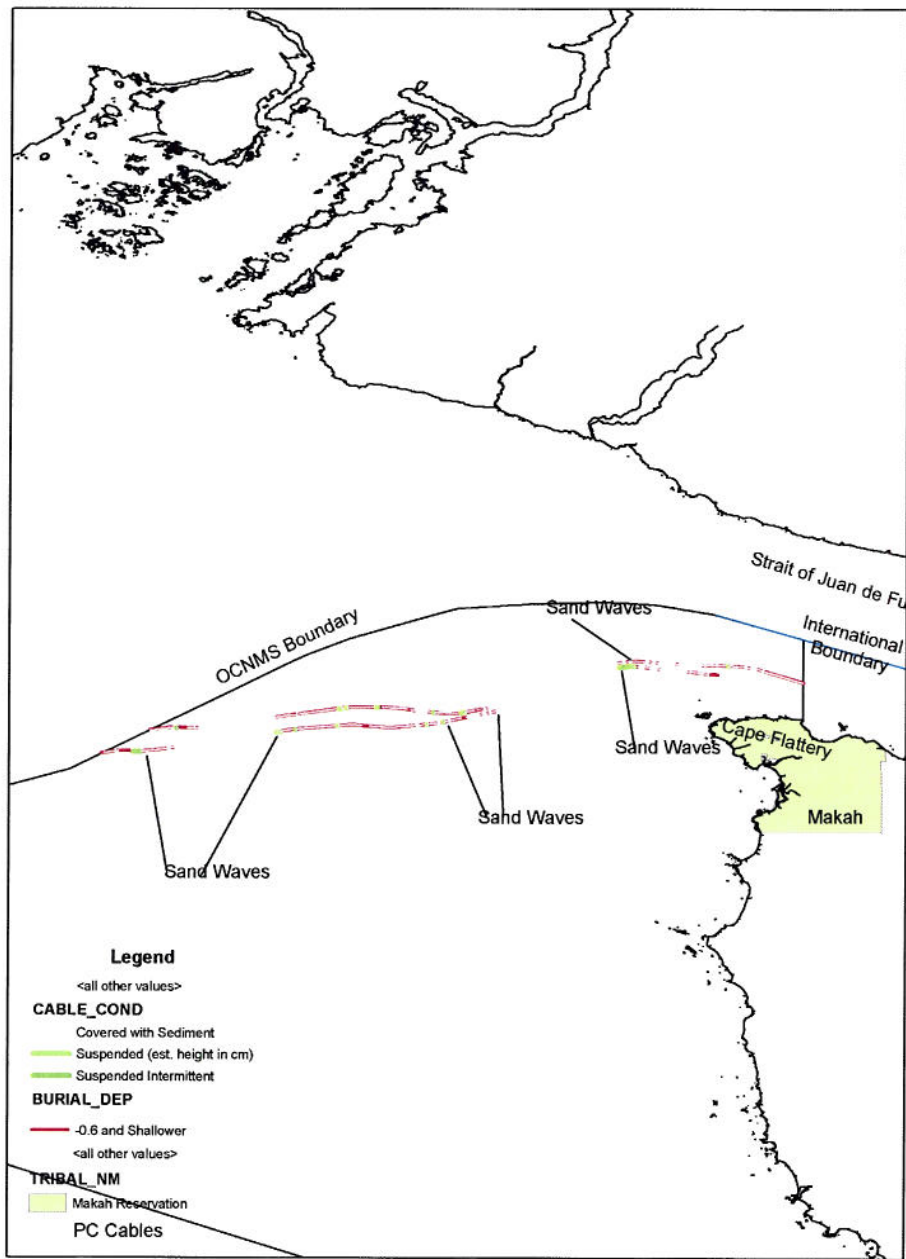
Figure 3 Location of Sand Waves on Pacific Crossing-1 Cable Routes in the Olympic Coast National Marine Sanctuary

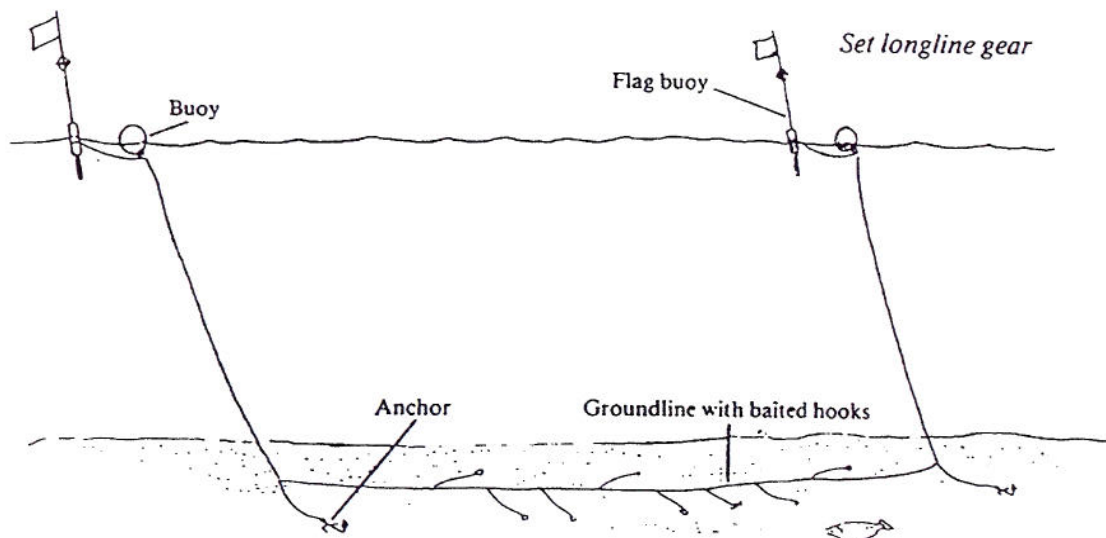
Figure 4 Typical Longline Fishing Gear

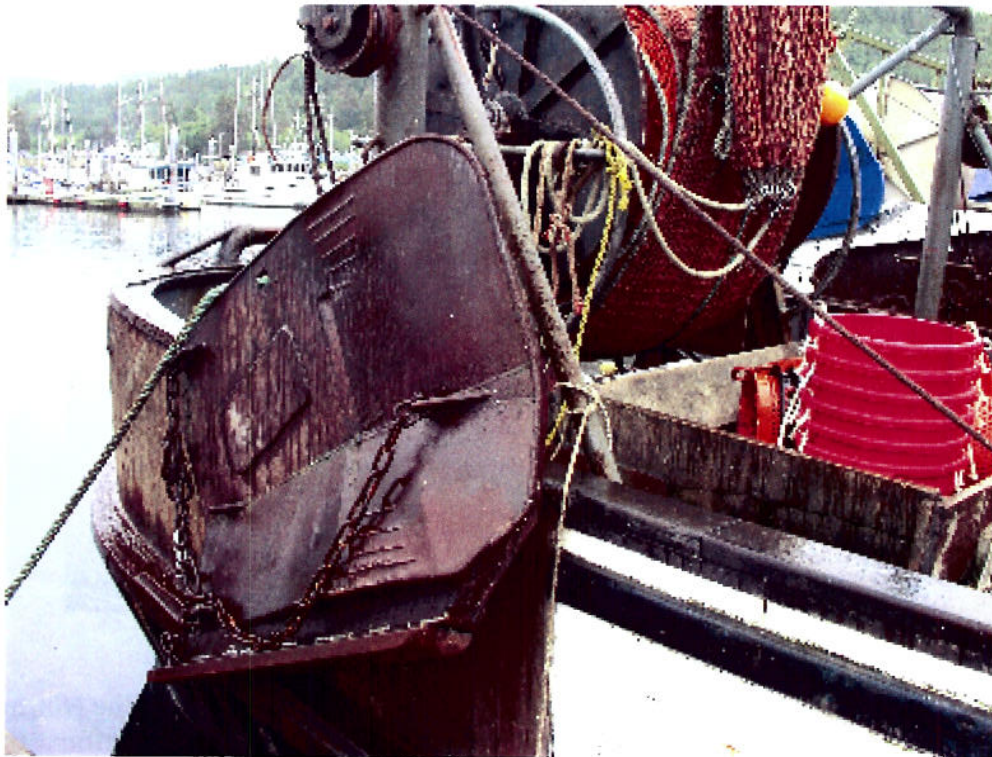
Figure 7 Typical Bottom Trawl Door

According to reports from captains who fish off the Washington coast, trawl doors typically penetrate approximately 0.13 m (4 to 6 inches) in soft mud, based on visible scouring on the rusted metal shoes welded to the bottom of the trawl doors (Jeff June, NRC, Inc., personal communication). This estimate matches a widely quoted estimate for penetration of trawl doors under tow of 0.15 to 0.3 m (6 to 12 inches) in soft mud and less in firmer sediments (Meggitt 1999, Hoshina and Featherstone 2001, CCC 2002). However, maneuvers such as the initial set (bottom contact) of the trawl doors or sharp course alterations on soft ground can cause trawl doors to bury as much as 0.5 m (1.6 feet) (Meggitt 1999). As a result, shallowly buried fiber optic cables less than about 0.5 m below the sediment surface are at risk of being hit or snagged by trawl gear (see Section 5.6.2). This level of risk is not static; redistribution and erosion of sediment overlying a fiber optic cable can reduce the sediment cover and increase the risk of fault from such external aggression (see Section 5.2).

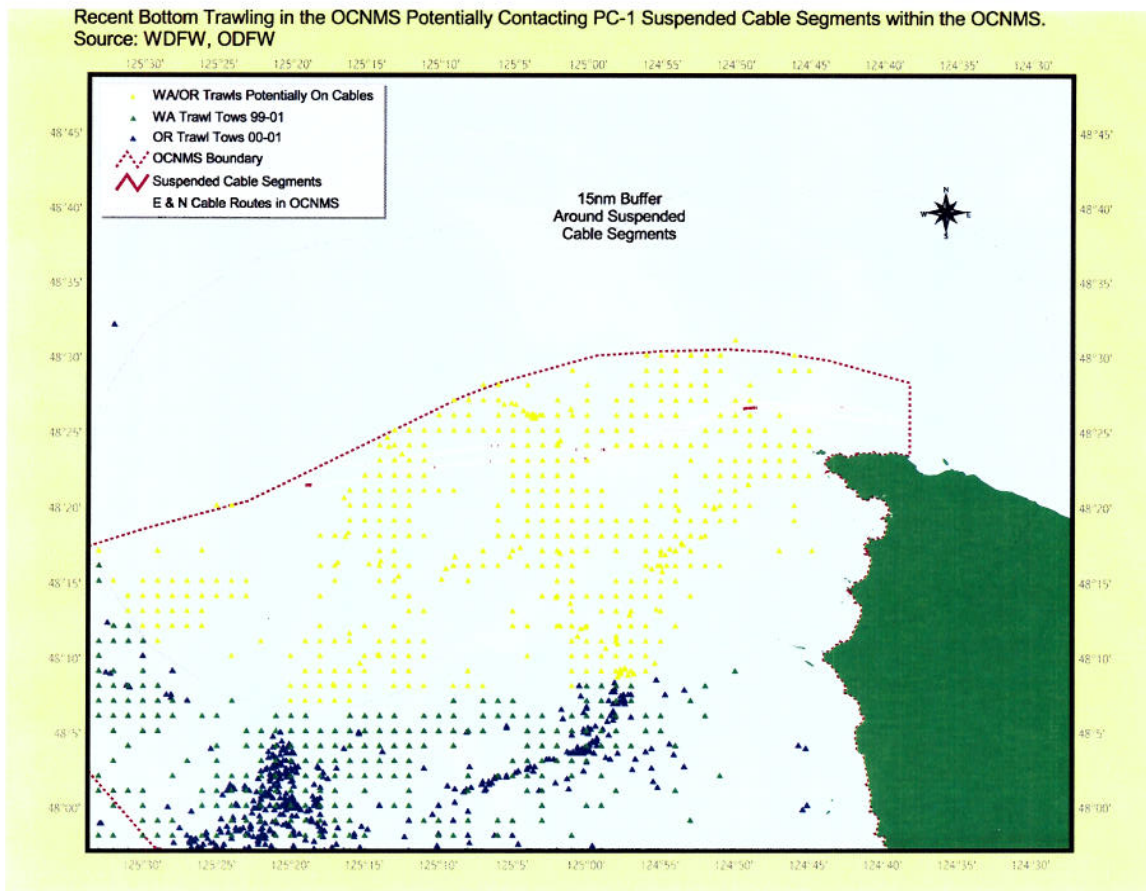
Figure 8 Recent Bottom Trawling Effort in the OCNMS with Potential to Contact Shallow Buried, Unburied, and Suspended Areas of the PC-1 Cables (Pacific Crossing-1 cable routes are indicated in a black line. The Sanctuary boundary is shown as a red, dashed line.)

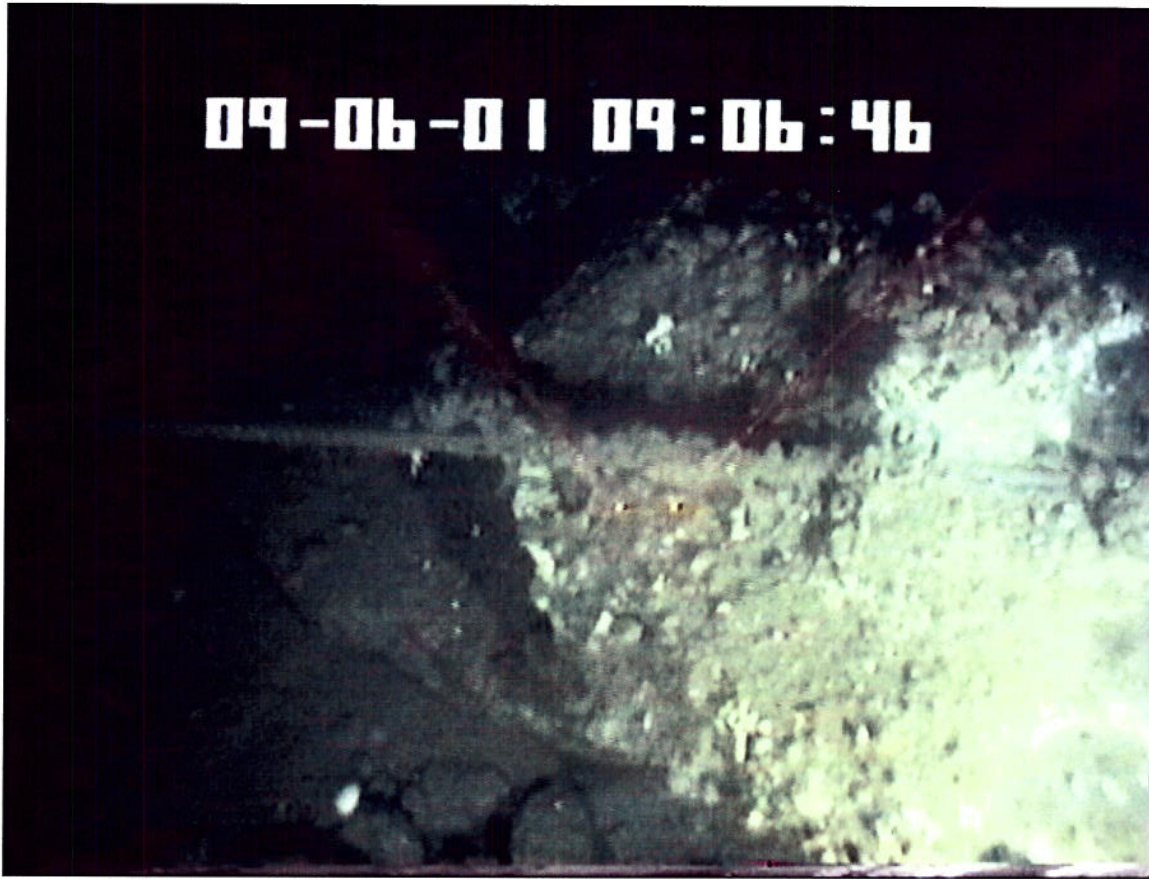
Figure 12 The PC-1 Fiber Optic Cable with Visible Serving Damage Atop a Boulder in the OCNMS

Serving damage, or damage to the outer protective layers of the cable, and exposed armor were noted in several places (Tyco 2000b, ERM 2002). Such damage could have occurred during installation as the cable passed through the plow, or it could have happened after installation due to external aggression, such as chafing against rock or contact with trawl gear. Observations of frayed cable serving and exposed metal armoring with a fresh or polished appearance where cable is laid over boulders indicate that physical damage to outer armoring layers of the cables has occurred after installation and that cables may be at risk of fault at these locations (Figure 12, see Section 5.6.1).

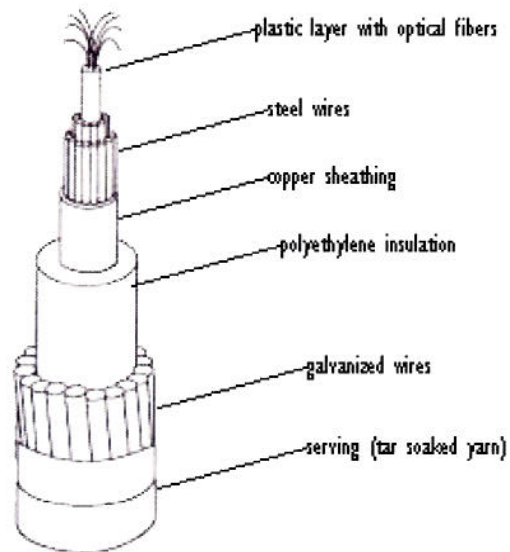
Figure 13 Light Wire Armored Cable
